### Supplementary 1.

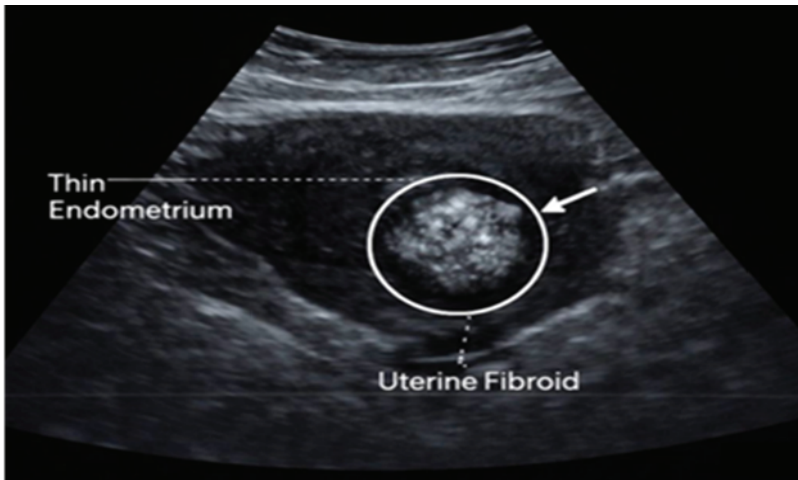
### Supplementary 2.

Transabdominal ultrasound image showing a non-calcified hypoechoic uterine fibroid in a postmenopausal woman.
